Manhole Inspection Summary

Manhole # S23SS1005MH

Location Address: **4909 FALLS RD**

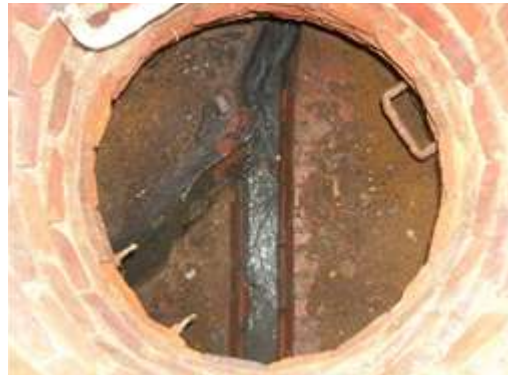
Top View

Bench ☒ Exists Material: **Brick** ☐ Parged ☒ **Debris** (not Condition related)

Steps Count: **3** Missing: **1** ☒ **Corroded**

Surcharge ☒ **Evidence Of Surcharge** Depth: **1.5** (ft.) ☐ Active Surcharge Present

Corroded and missing steps. Evidence of surcharge - Bench debris.

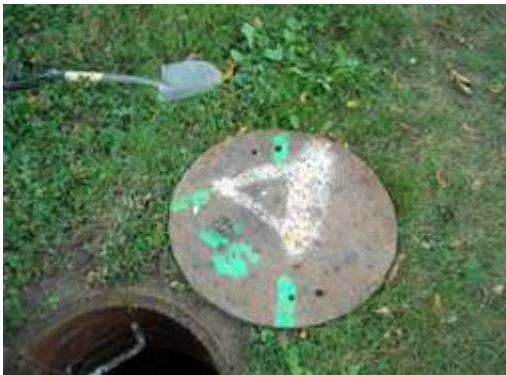
Defect

Comments **NO PICK HOLES, 21" IN DIAMETER**

21" DIAMETER LID; UNKNOWN TYPE

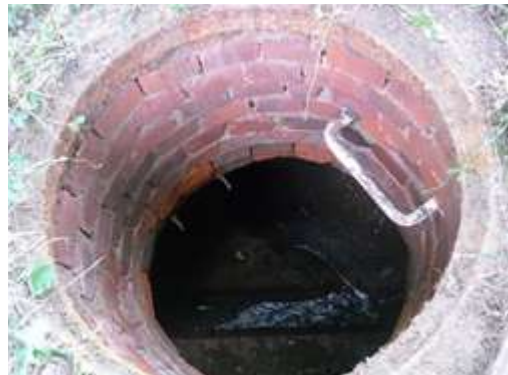
Condition: ☐ Sound ☐ Cracked ☐ Root Intrusion ☐ Loose Brick ☒ **Deteriorated**

Infiltration: ☐ None ☒ **Joint** ☐ Cracks ☐ Mortar ☐ Roots ☐ Wall

Corbel deterioration and infiltration.

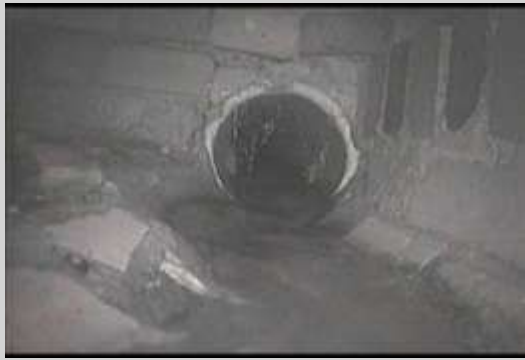
8 in. Circular Gravity Sewer Pipe Out @ 12 O'Clock

Infiltration: **Evidence** Pipe Seal Cond: **Roots**
